BULGARIAN FIGHTER COLOURS 1919–1948

Vol. 1

Rainbow No 9136

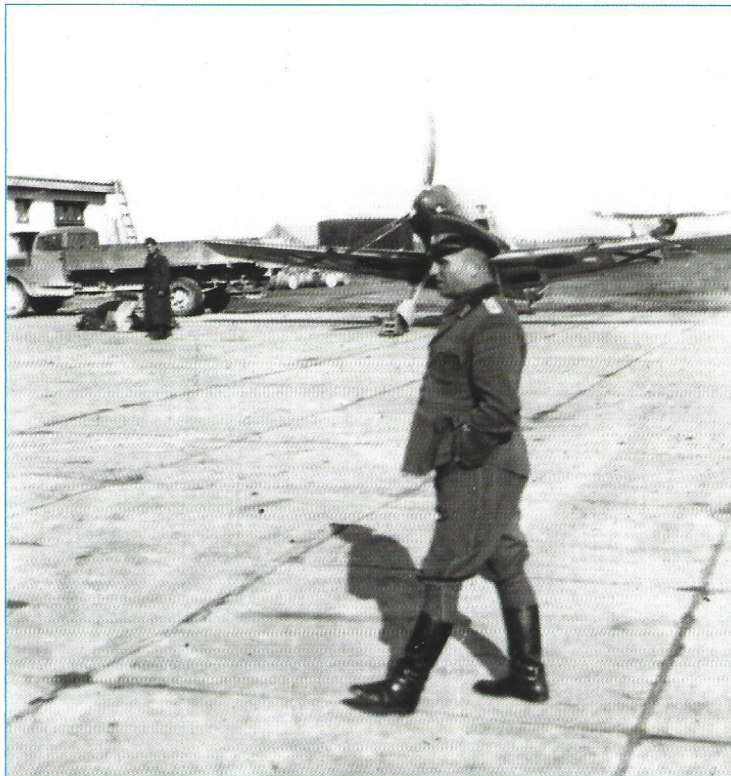
The front view of the same No. 5 is seen here, in company of *Kapitan* Krăstyo Atanasov (foreground), commanding officer of 3/6. Orlyak. The biplane in the background, at right, is a *Vrana* (Letov Š.328).

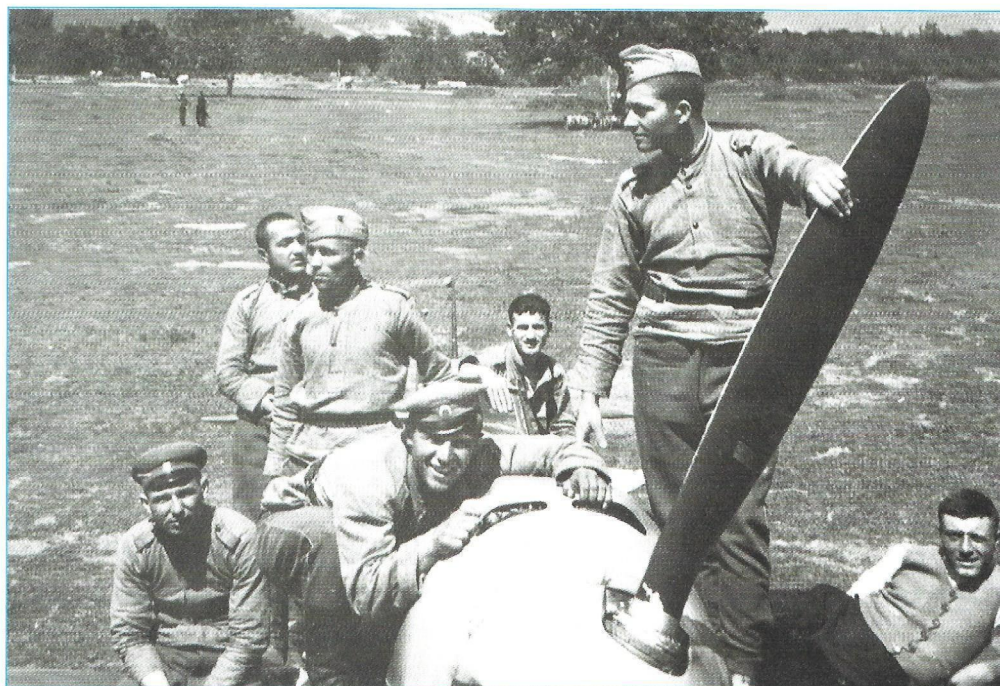
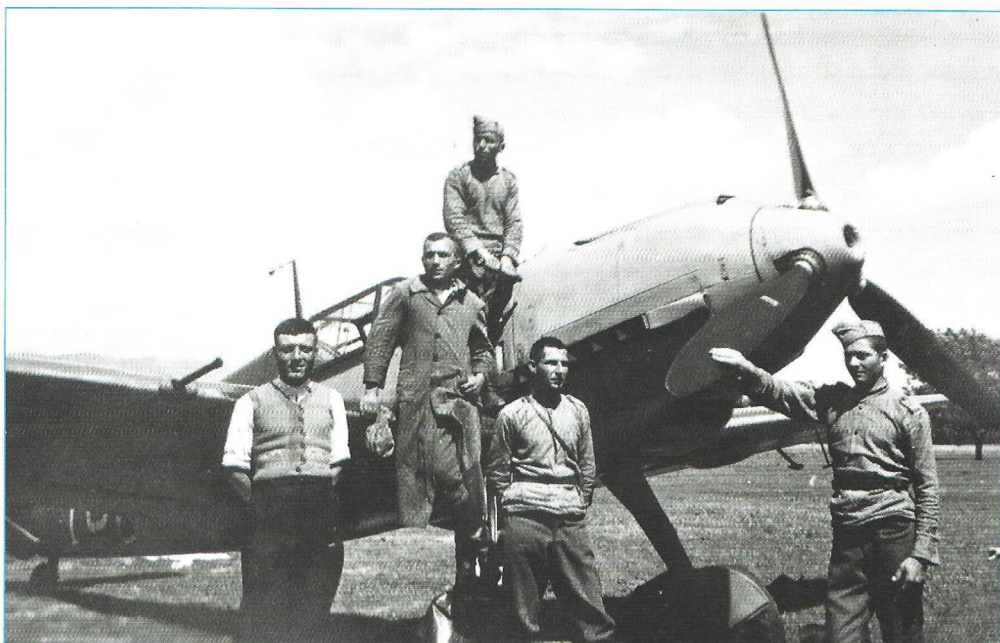
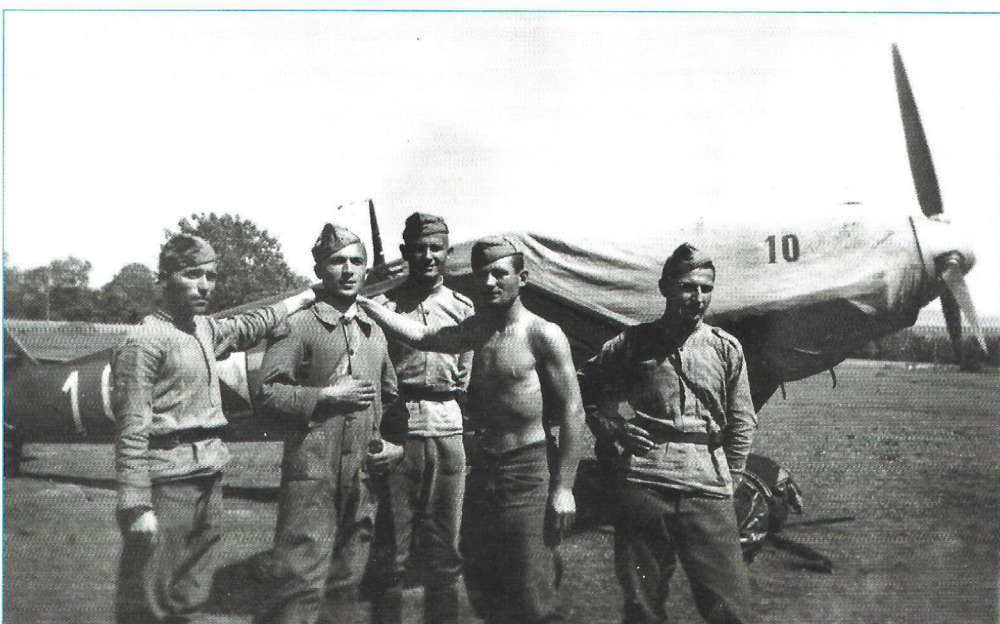
*These three photos depicting
No. 10 and ground personnel
were taken on Asen landing
ground. The wing cannon are
already installed.*

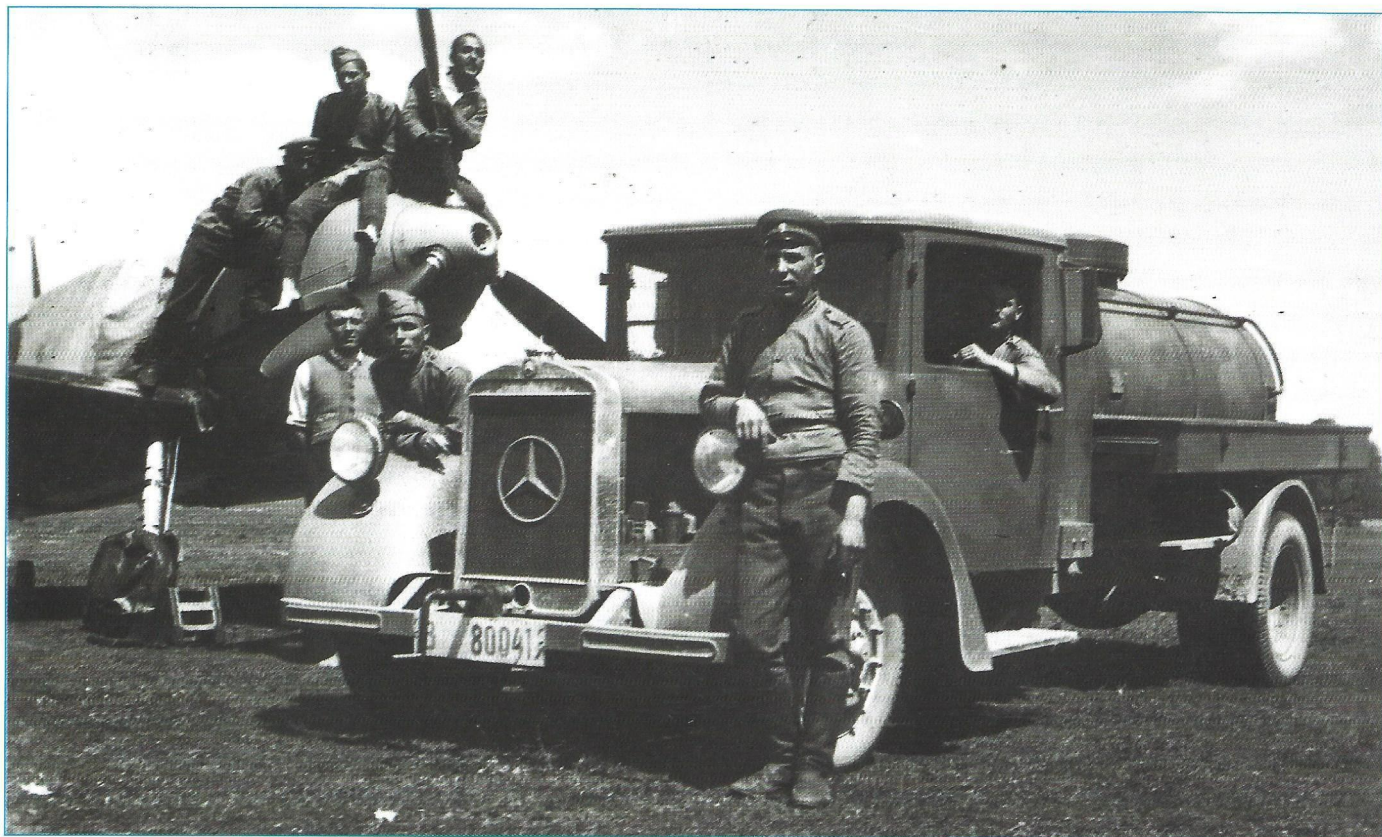
A Strela (possibly No. 10) is being refuelled on Asën landing ground by a Mercedes-Benz Lo 2000 fuel tanker. The military licence plate, B 80041, identifies it as 'special purpose vehicle', as per military control number allocation order of 15 July 1938. At that time, vehicles of the air force were not yet separated from army vehicles, hence the B prefix (read: V, as Voenen, i.e., Military), as opposite to BB (read VV, Văzdushni Voyski, i.e. Air Force), introduced later.

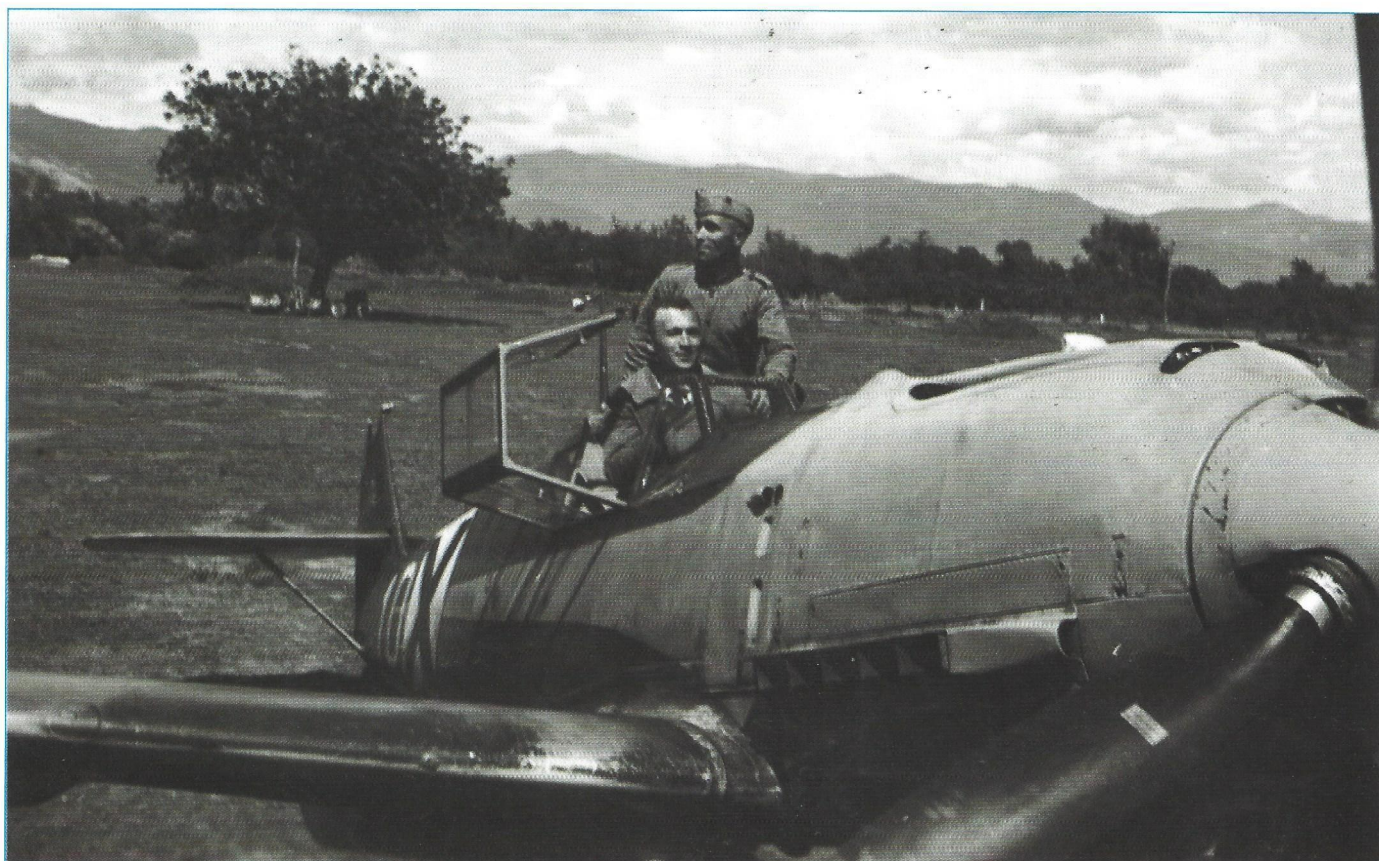
Beautiful scenic shot of Strela E, No. 10, possibly made by the photographer standing on the fuel tanker depicted in the previous photo. It was most probably also taken at Asën landing ground. Notice the absence of the 20 mm cannon from the wing, the port being covered by sheet metal. Apparently, the worn areas of the leading edge were patched with some sort of dark green colour.

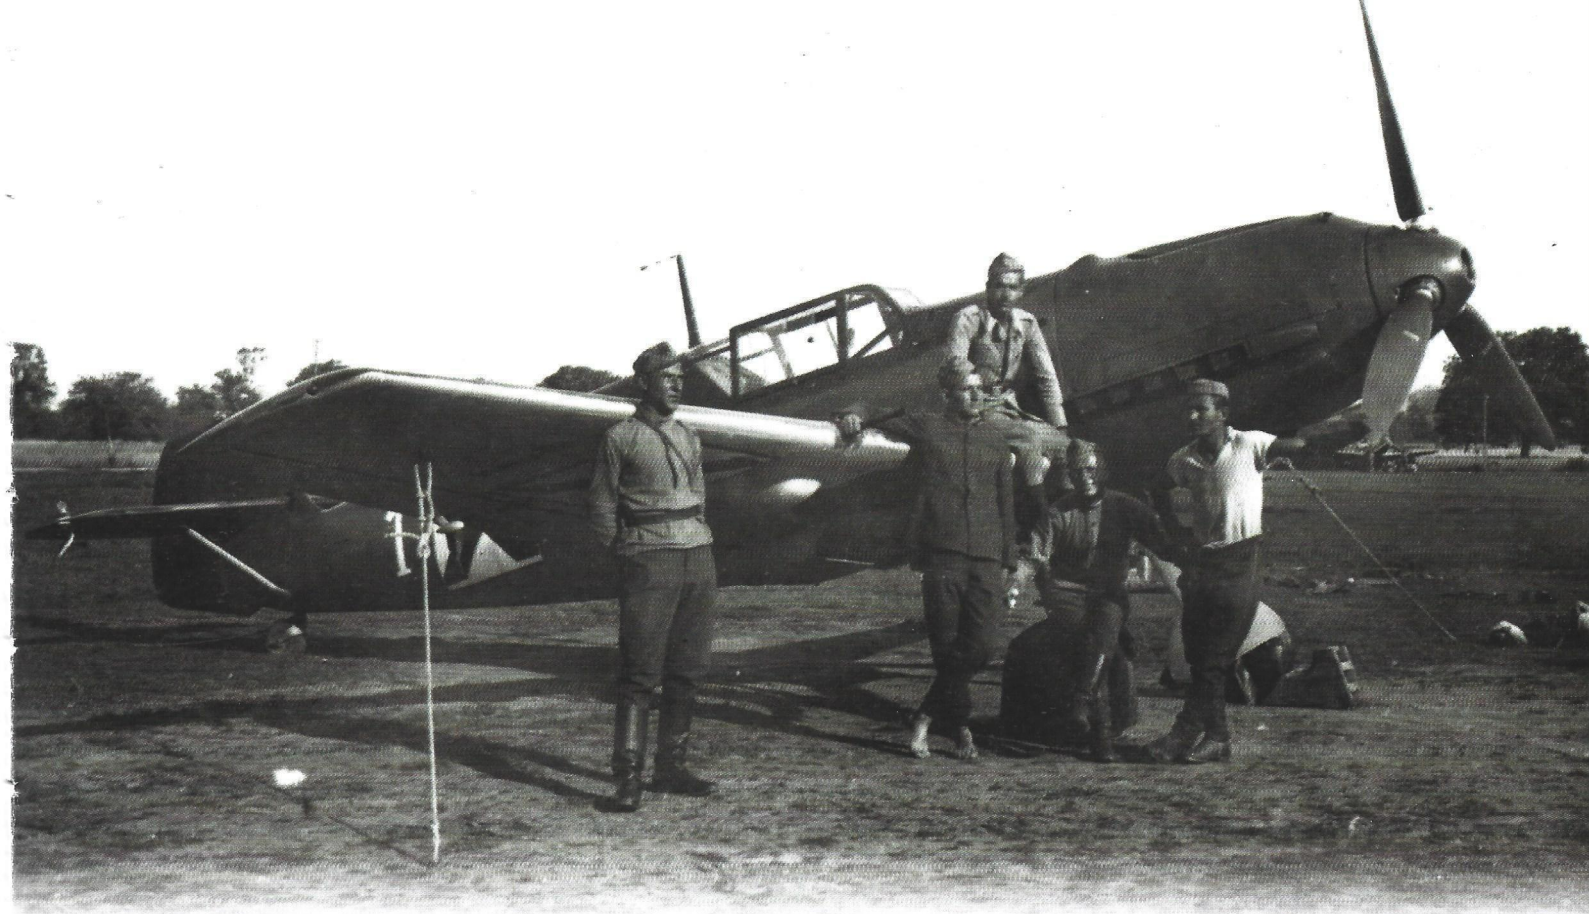
The first Strela, No. 1, is depicted during manoeuvres, probably on Asen airfield. The wing cannon are already installed.

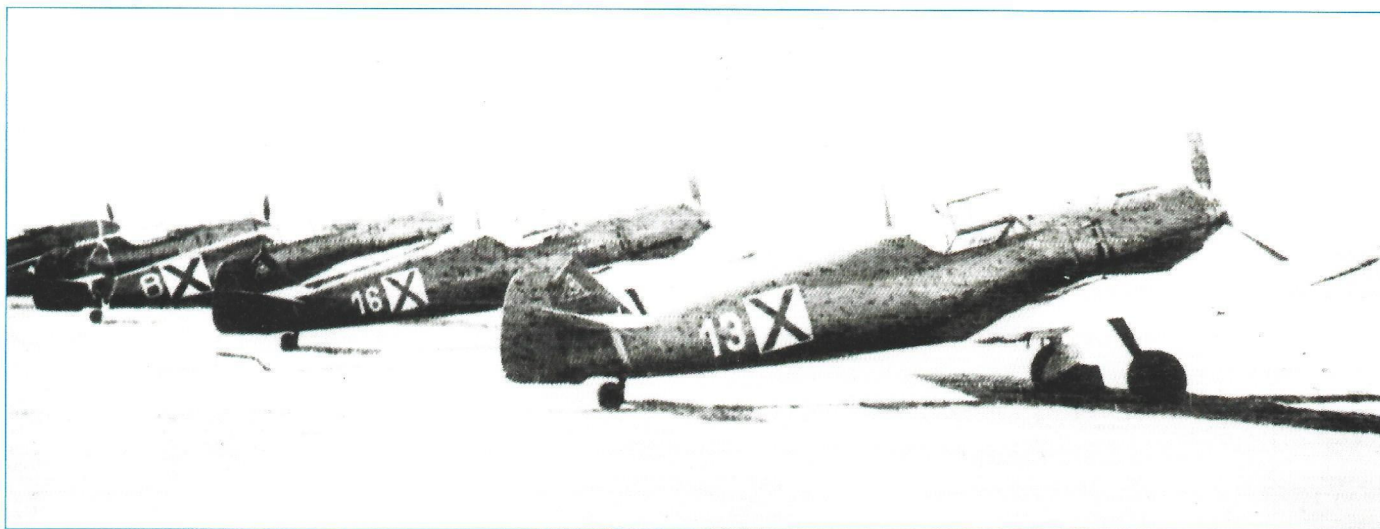
Other aircraft of the second batch arrived in mono colour upper surfaces of Dark Green (possibly RLM 71), over Light Blue (RLM 65), as seen on bellied No. 14. This particular aircraft was damaged 40% when the careless Feldfebel Tsvetan D. Gruev of 692. Yato forgot to lower the undercarriage while landing on Marno-Pole airfield on 22 March 1943. Only nine days later, this very aircraft was lost in a fatal in-flight accident, which claimed the life of Podofitser Penyo D. Malev of the same squadron.

The 7th April was a black day for the airmen flying the *Emil*. That day, the first recorded fatal accident happened. After the engine of No. 14 caught fire in mid-flight, the stranded pilot, *Podofitser* Penyo D. Malev of the 692nd *Yato*, bailed out of the burning aircraft, which was now flying out of control at over 600 km/h. His Schroeder type parachute shredded to pieces due to the high speed, and the unlucky pilot fell to his death at Voynyagovo, south-west of Karlovo. Only eight days later another fatal accident happened. This time, the rudder of No. 15 detached while the pilot was making a loop during aerobatics. The uncontrollable aircraft fell to the ground near Balchik, taking its pilot, *Por.* Ivan I. Rusev, to his death. Obviously, the double deaths, both apparently caused by aircraft failures, shook the morale of the Messerschmitt pilots. In only 18 days, three Bf 109Es were lost, all from the second batch, by coincidence Nos. 13, 14 and 15²⁰. Nevertheless, after the investigations concluded, flights had to continue.

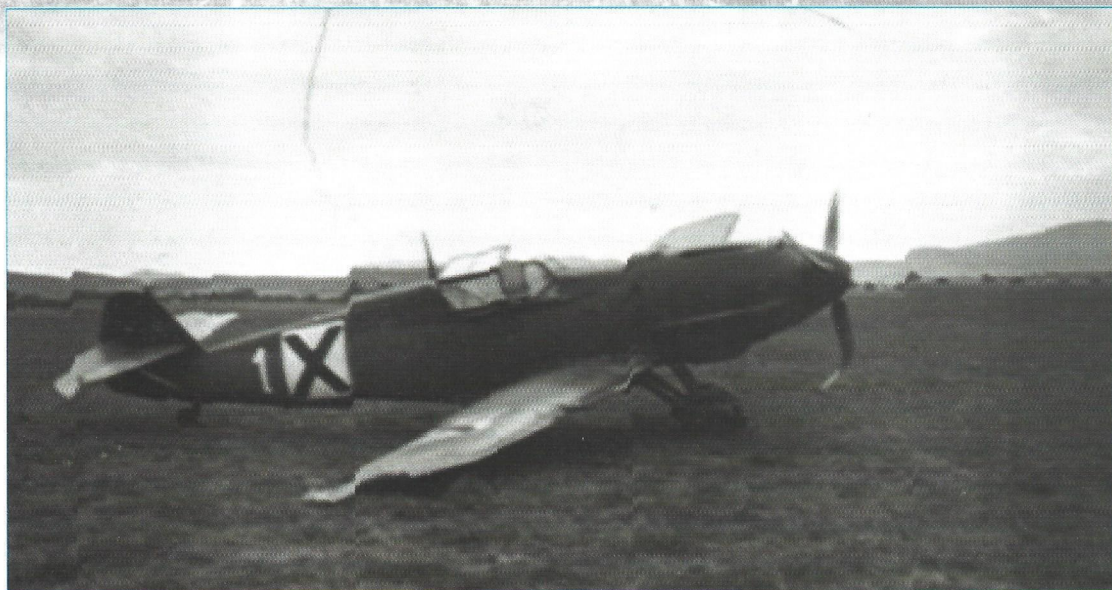
Most of the accidents were not fatal, and the aircraft could be subsequently recovered. Such a minor accident happened to No. 1 on 10.05.1943, when Podporuchik Marin A. Tsvetkov of 672. Yato performed a hard landing on Mar-no-Pole airfield, damaging the aircraft 10%.

Despite no more fatal accidents happening in 1943, smaller incidents were recorded. Among them were the 'usual' bad landings, one of them occurring on 10 May, when *Podporuchik* Marin A. Tsvetkov of the 672nd *Yato* bent the starboard undercarriage of No. 1 while landing on Marno-Pole airfield, causing 10% damage. More minor damage was suffered by aircraft No. 5, whose propeller was damaged by a Letov Š.328 *Vrana* taxiing on Balchik airfield on 4 July.

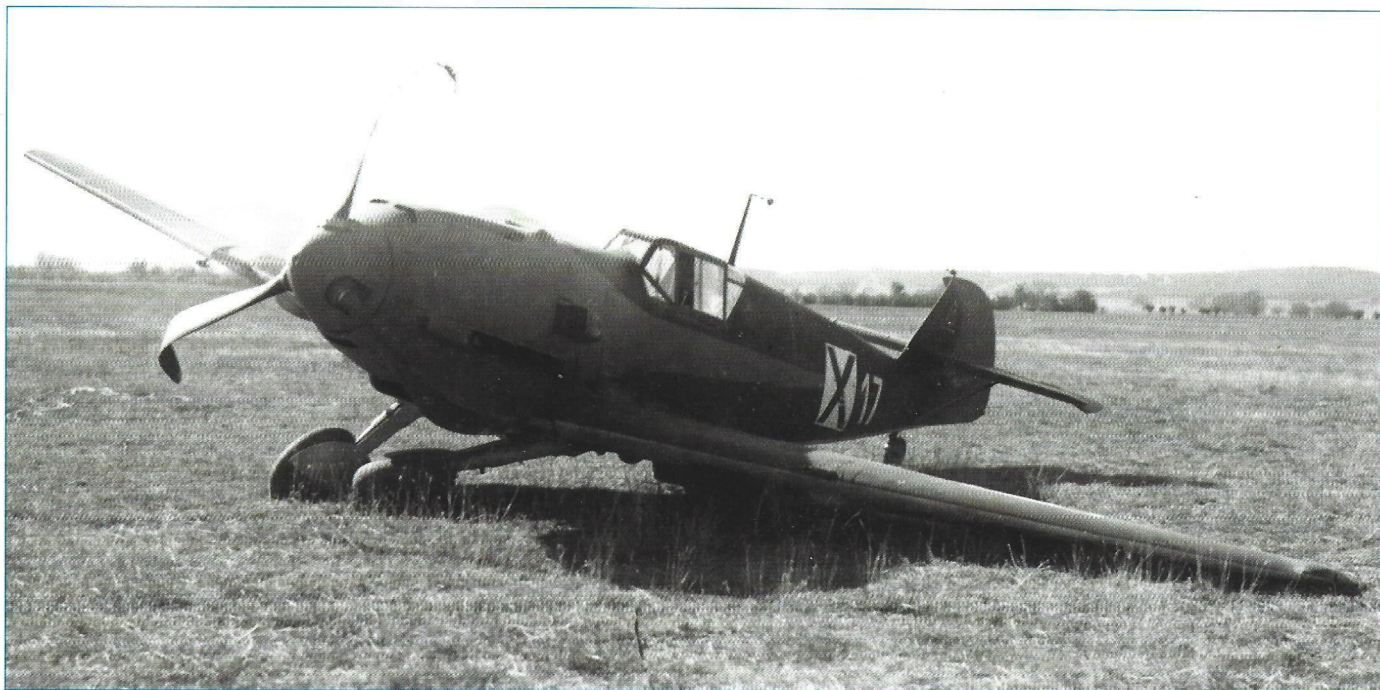
A similarly light accident was suffered by No. 17 at an unknown date, this time to the port undercarriage. Typically, following such a taxiing accident, the unlucky aircraft could be rendered serviceable again within a week's repair work.

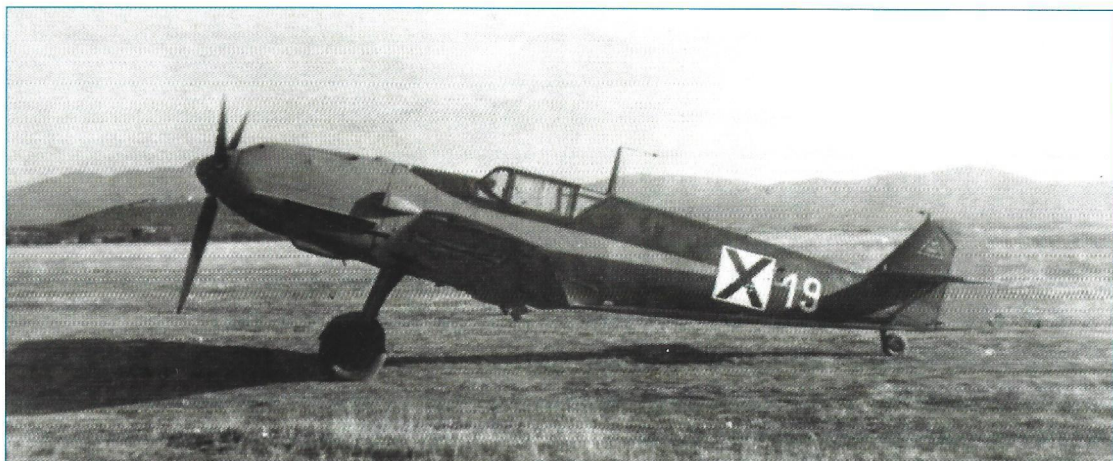
No. 19 (W.Nr. 6012) was the last Emil to see service with the VMV. This particular aircraft was flown by top pilot Stoyan Stoyanov at Karlovo on 10 and 14 October 1941. Little else is known of its service life, except that it was eventually struck off charge on 1 August 1944.

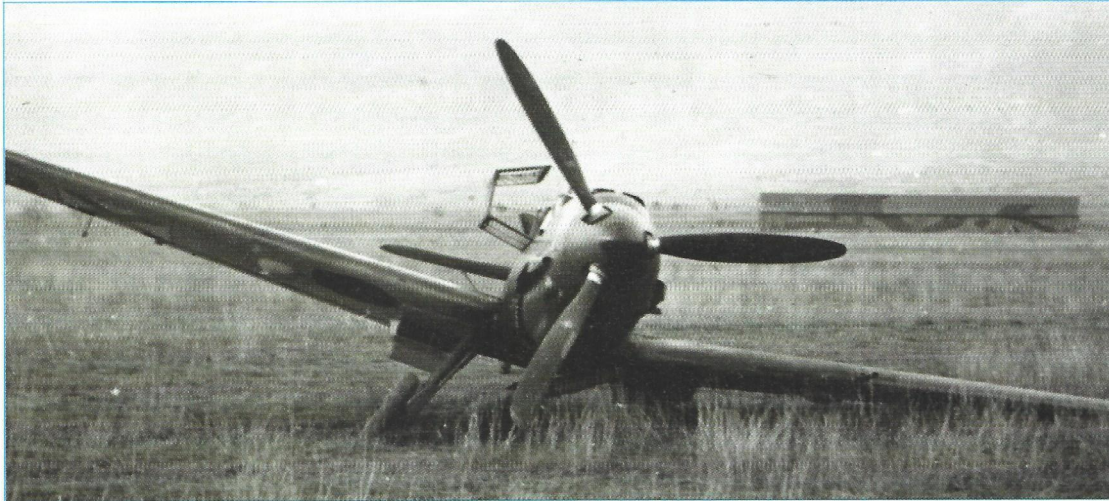
Strela No. 3 of the 682. Yato, piloted by Kpt. Nikola M. Videnov, was involved in a minor accident on 6 September (or November) 1942, when it veered off the runway during taxi and its port undercarriage leg collapsed on the rough terrain of Marno Pole (Karlovo) air base, causing 20% damage. The front view reveals a strange detail, namely that only the port wing cannon was installed! As noted in the main text, the 2 cm (20 mm) MG-FF (Ikaria) wing cannon were retrofitted after the aircraft's arrival, as they were shipped separately. Notice the patchwork around the cannon barrel root.

The autumn months of September, October and November were marred by further incidents, as follows: on the 6th September, *Strela* No. 3, piloted by *Kapitan* Nikola Videnov from the Marno Pole air base command, was involved in a minor accident when it veered off the runway during taxi and its port undercarriage leg collapsed. On the 14th, a parked aircraft, the same unlucky No. 3, in the hangar at Balchik was damaged when an out-of-control Letov Š.328 *Vrana* reconnaissance biplane rammed it. On the last day of October, *Zamestnik ofitser* Ivan N. Bonev had to force-land his mount, No. 10, after the engine quit in mid-flight. Luckily, he reached Balchik airfield, so both he and his machine escaped. Finally, the last accident of the year involving a *Strela* was also a result of engine malfunction. During take-off from Marno Pole, the DB 601A powerplant of the freshly repaired, but apparently very unlucky, No. 3 suddenly stopped at 50 m altitude, compelling the pilot, *Kapitan* Nikola M. Videnov¹⁸, to belly land his aircraft, which sustained 20% damage. This incident reportedly happened on 06.11.1942¹⁹.

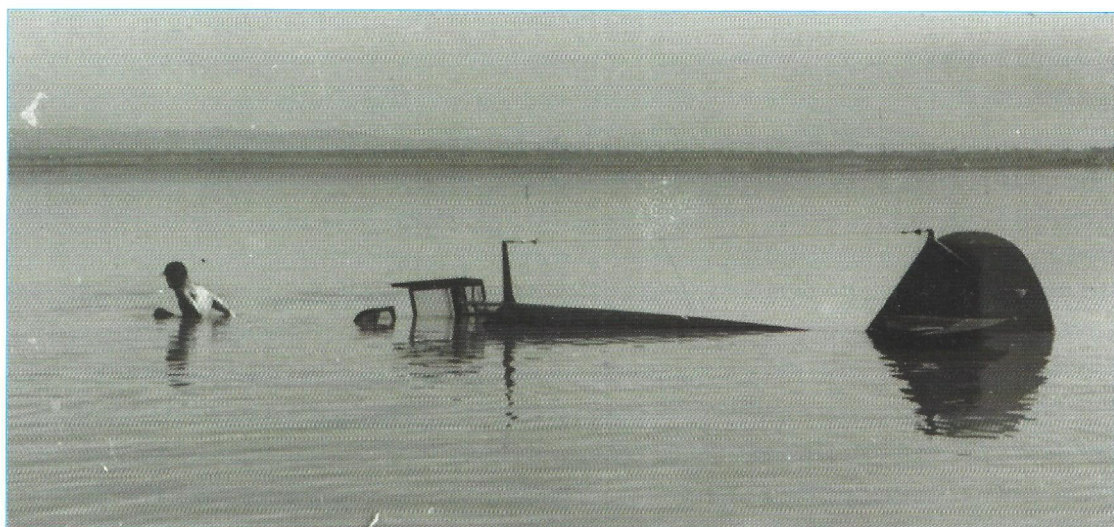
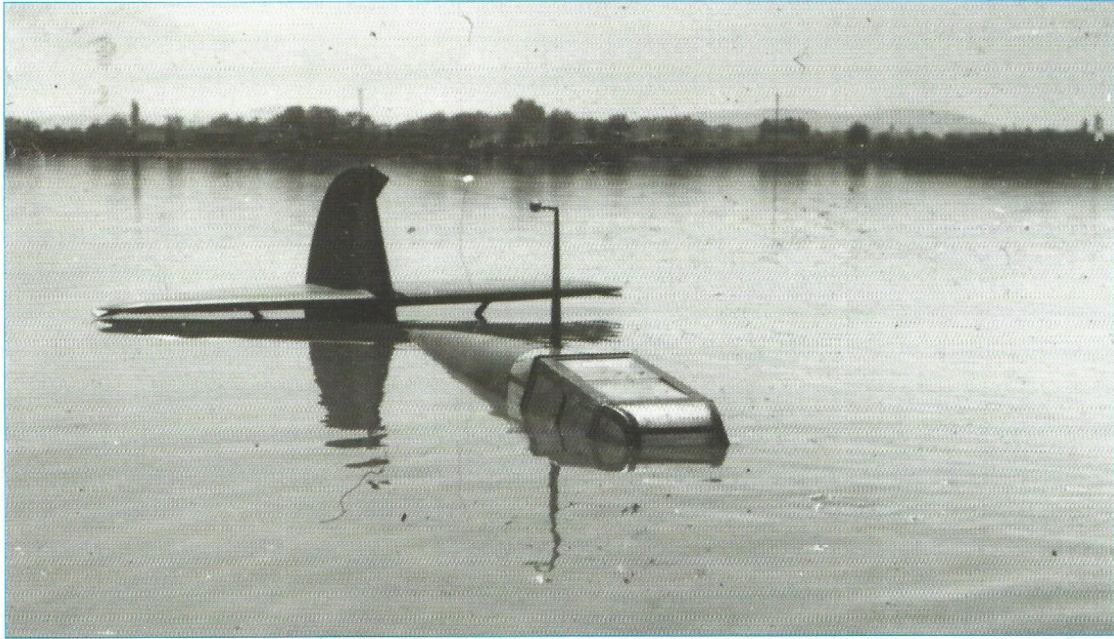
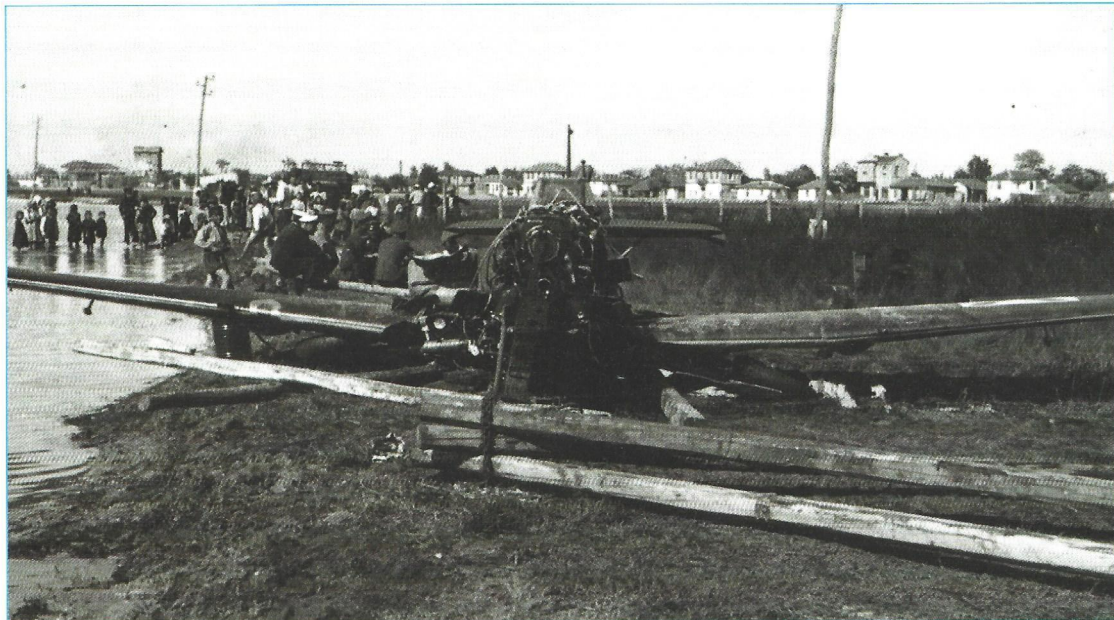
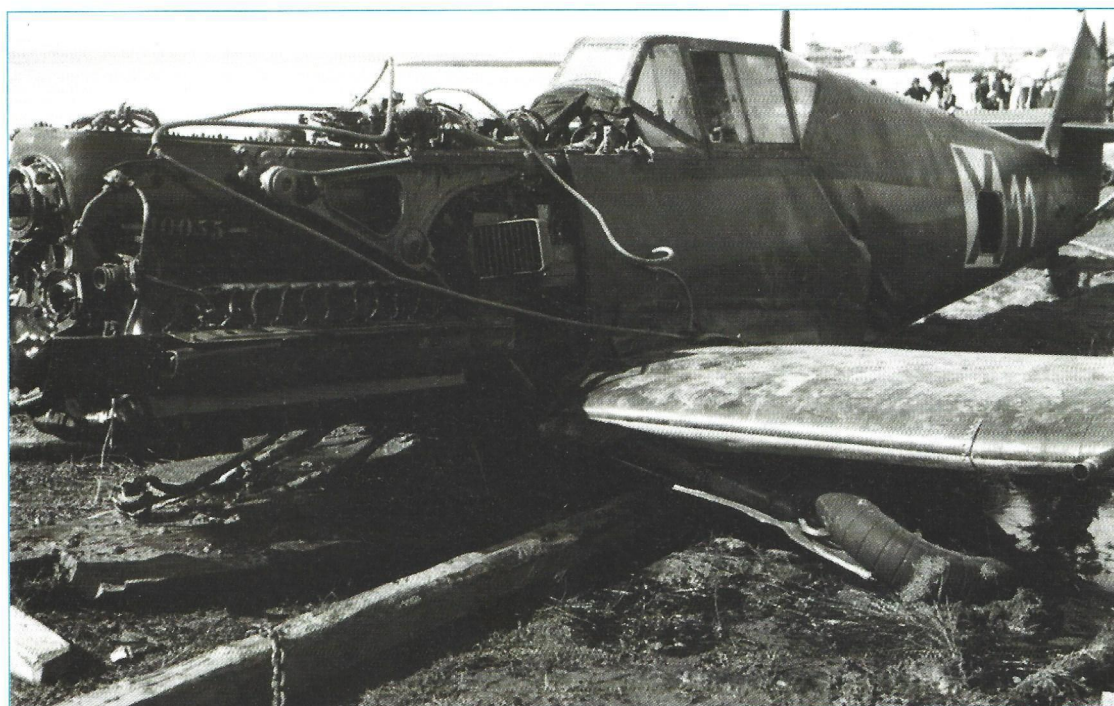
Emergency ditchings not necessarily happened in the Black Sea. This incident, depicted in this series of four photographs, involved aircraft No. 11, which landed in the shallow waters of Lake Vayakyoisko, near Burgas on 30 May 1943. The pilot, Podporuchik Georgi R. Kyumyurdzhiev of 692. Yato, could swim ashore, and the half-submerged aircraft salvaged, despite the seriously twisted airframe.

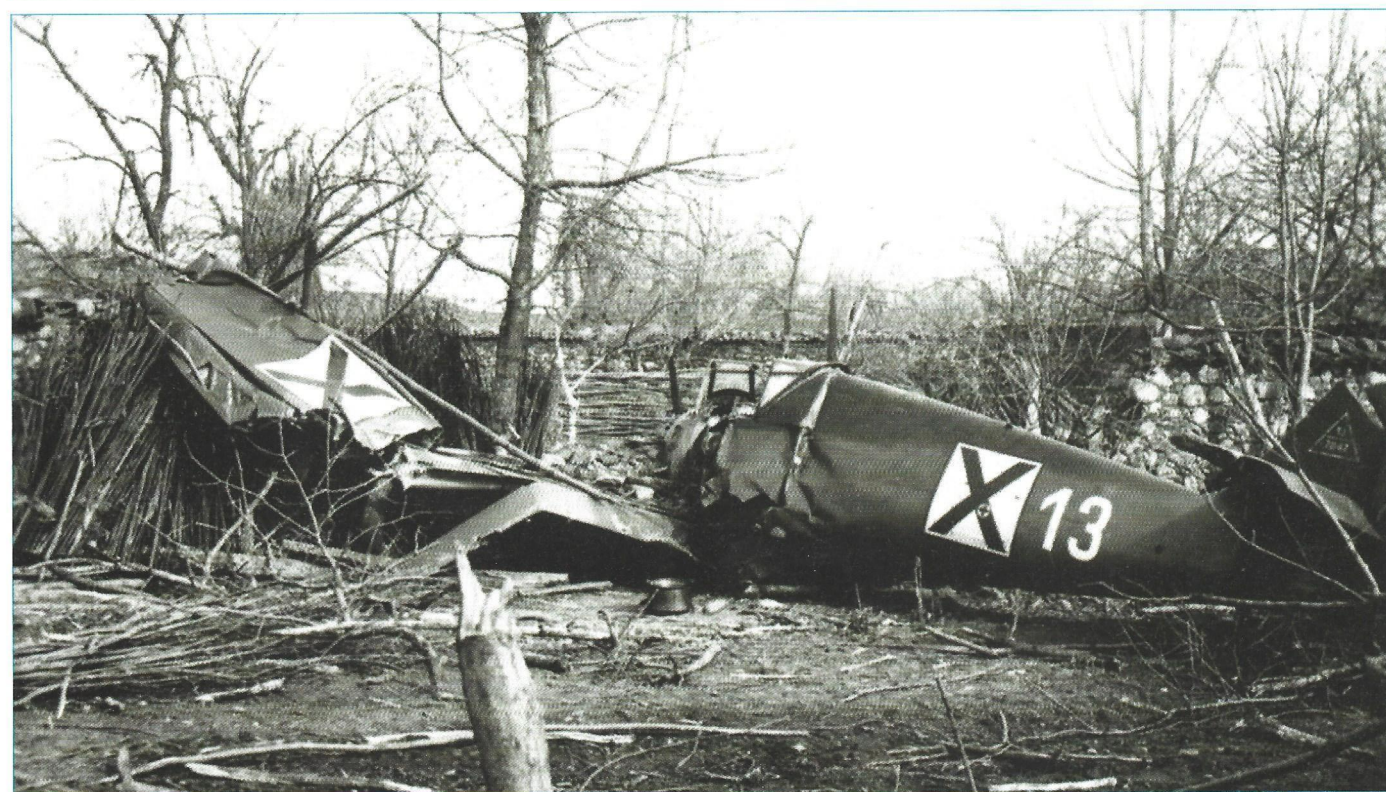
Below: A series of three accidents (two deadly) that incidentally happened to subsequently marked aircraft (Nos. 13, 14 and 15) in the span of only 18 days in the spring of 1943 left a deep mark in the memories of Emil pilots. These incidents were vividly recalled to the Author by one of the very few surviving witnesses, Petăr Manolev, over 60 years later. Depicted is No. 13, destroyed in a botched landing at Vedrare, on 29 March 1943.

Luckily, the pilot, Ppor. Georgi M. Georgiev, escaped alive, although wounded. The pilots of the other two aircraft (Nos. 14 and 15) were not that lucky, both perishing in the catastrophes.

Notice the barely visible rearward tapering yellow flash along the fuselage and also the barely visible nr. 13 on the port wing inner surface (the crack runs between 1 and 3).

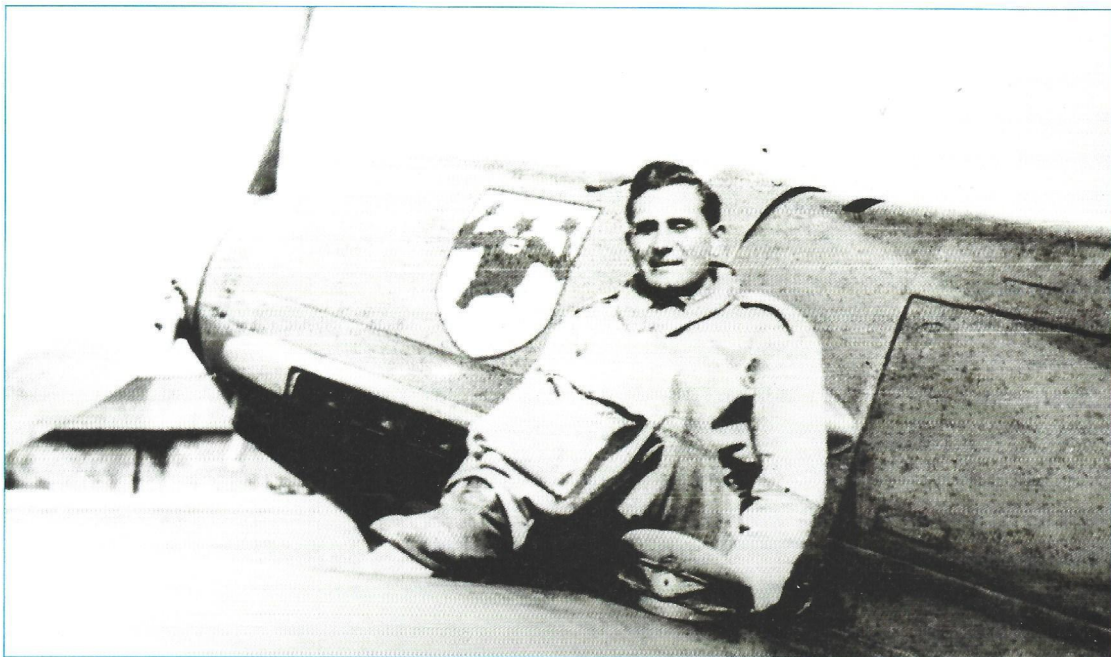
Something is unusual with this Emil depicted in Bulgaria. The spinner looks odd, and there is no trace of any marking on wing undersurface, or fuselage side. Also, the camouflage colour on the lower fuselage side looks way too dark, and the wavy demarcation line is also weird. The usual rearward tapering flash along the fuselage is also missing.

One possible explanation is that this airframe is unserviceable, and was photographed after the war, parked on a forgotten corner of an airfield.

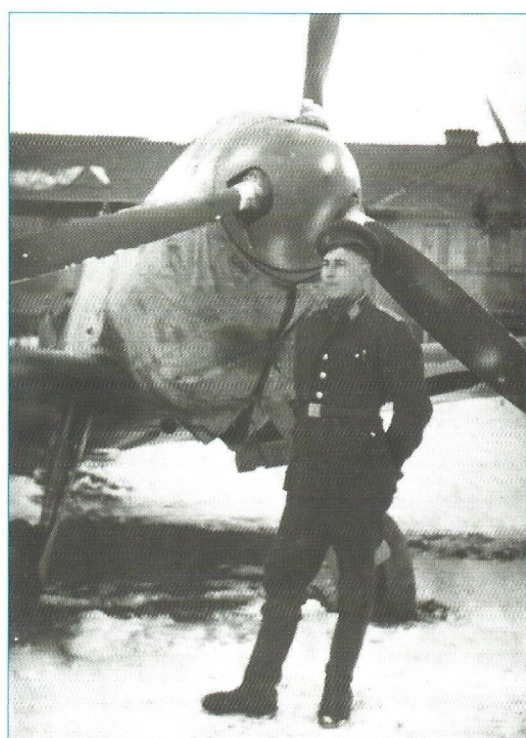
Not much useful information can be drawn from this photo showing a Bf 109E covered with protective canvas. However, the spinner is well visible, and the light grey mottles sprayed over it are quite unusual. This photo could have also been taken in the immediate post-war period.

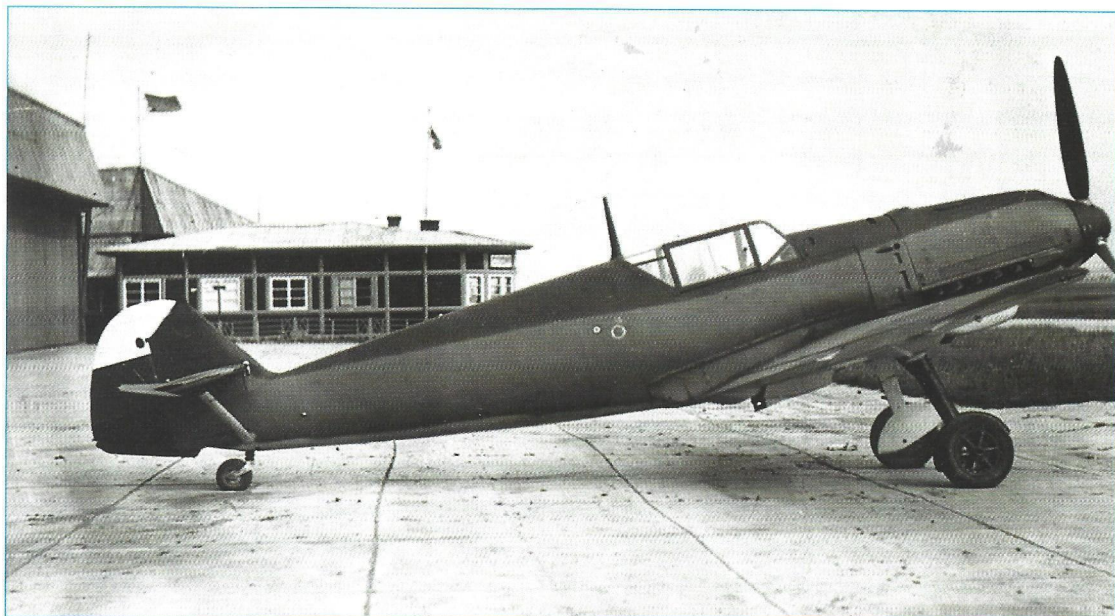
Side view of one of the first Bf 109E-3s following the assembly at DSF-Bozhurishte in late April 1940. The camouflage – consisting of Dark Green (L 40/70 DKH) top surfaces, mid-Green (L 40/62 DKH) on fuselage sides and Light Blue (L 40/65 DKH) on the under surfaces – was painted on at the WNF, as was the Bulgarian tricolour on the rudder.

All other markings were applied in Bulgaria. Photo taken on 'Sofia' (actually Bozhurishte) airport, also used by civilian air traffic.

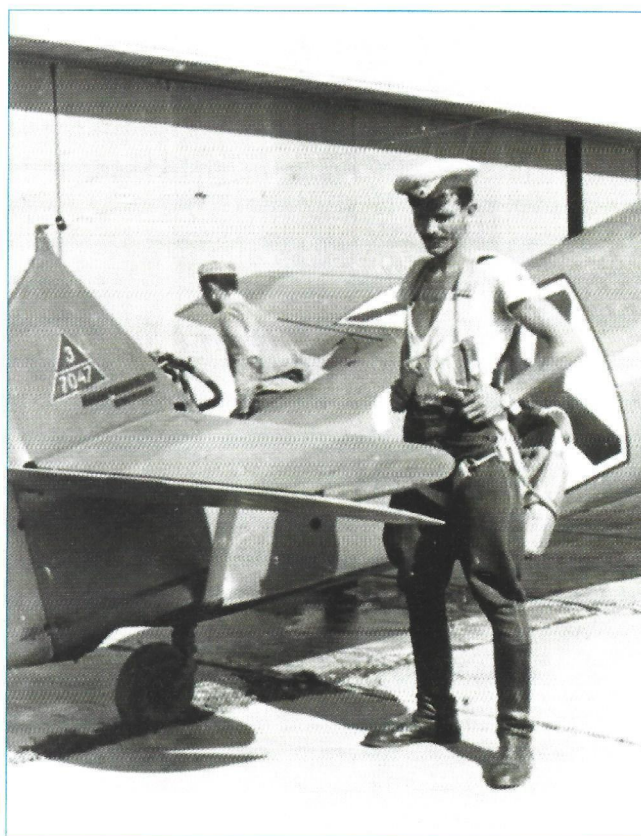
This photo of No. 3 reveals a minor, nevertheless important detail unnoticed so far the aircraft's type ('Messerschmitt Me 109') and the construction number (here 'W. Nr. 5223') were applied in the factory on both sides of the fin root, in Black, over what appears to be Black Green background. The pilot nearby the aircraft is Feldfebel Yordan S. Todorov 'The Pirate'. He became the first Bulgarian fighter pilot victim of the all-out air war with the USAAF. Todorov died in action on 14 November 1943, in a botched belly landing after suffering combat wounds in a dogfight with P-38 'Lightnings'. Notice how faded the L 40/62 Dark Green appears on this photo.

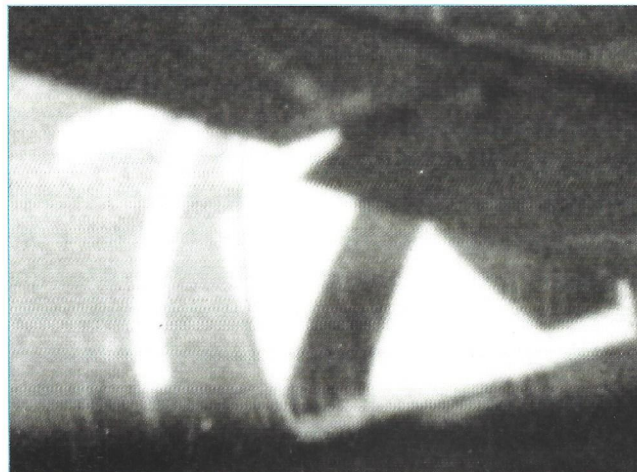
When the new Axis-style square-shape marking was introduced in late June 1940, attempt was made so it would cover the previous roundel-shape marking. However, the square could not be applied in large enough size to completely cover the roundel; therefore, small circle slices were occasionally left out. On this detail photo of aircraft No. 7, the attentive onlooker can spot the small white circle slices protruding outside the square on the fuselage side. Another notable minor detail is that the yellow flash was apparently painted over the old roundel, meaning that it was introduced at a later stage only.

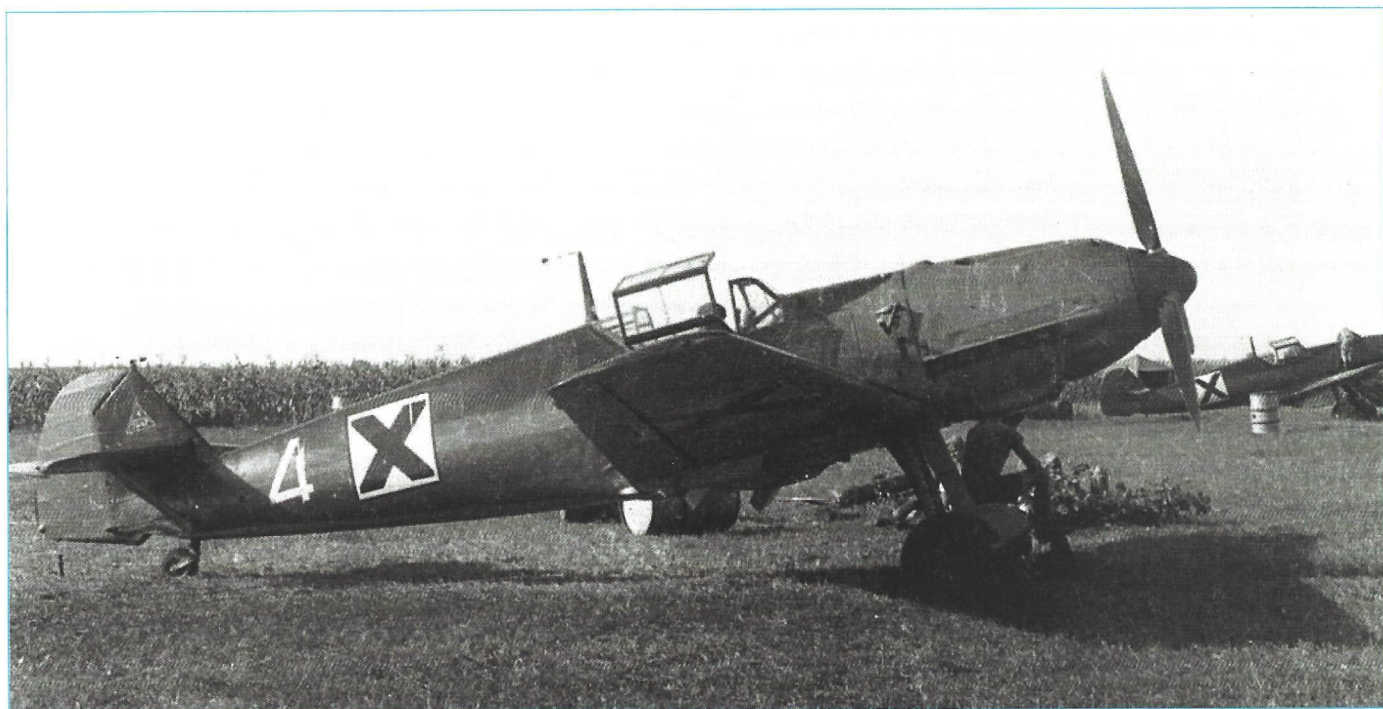
Close-up of a Bf 109E sporting the 'Red Devil walking on clouds, looking for its prey' emblem (clearly inspired by a Luftwaffe unit emblem). Ppor. Mihail Grigorov is crouching, at left, while Ppor. Pavel Pavlov is sitting, at right.

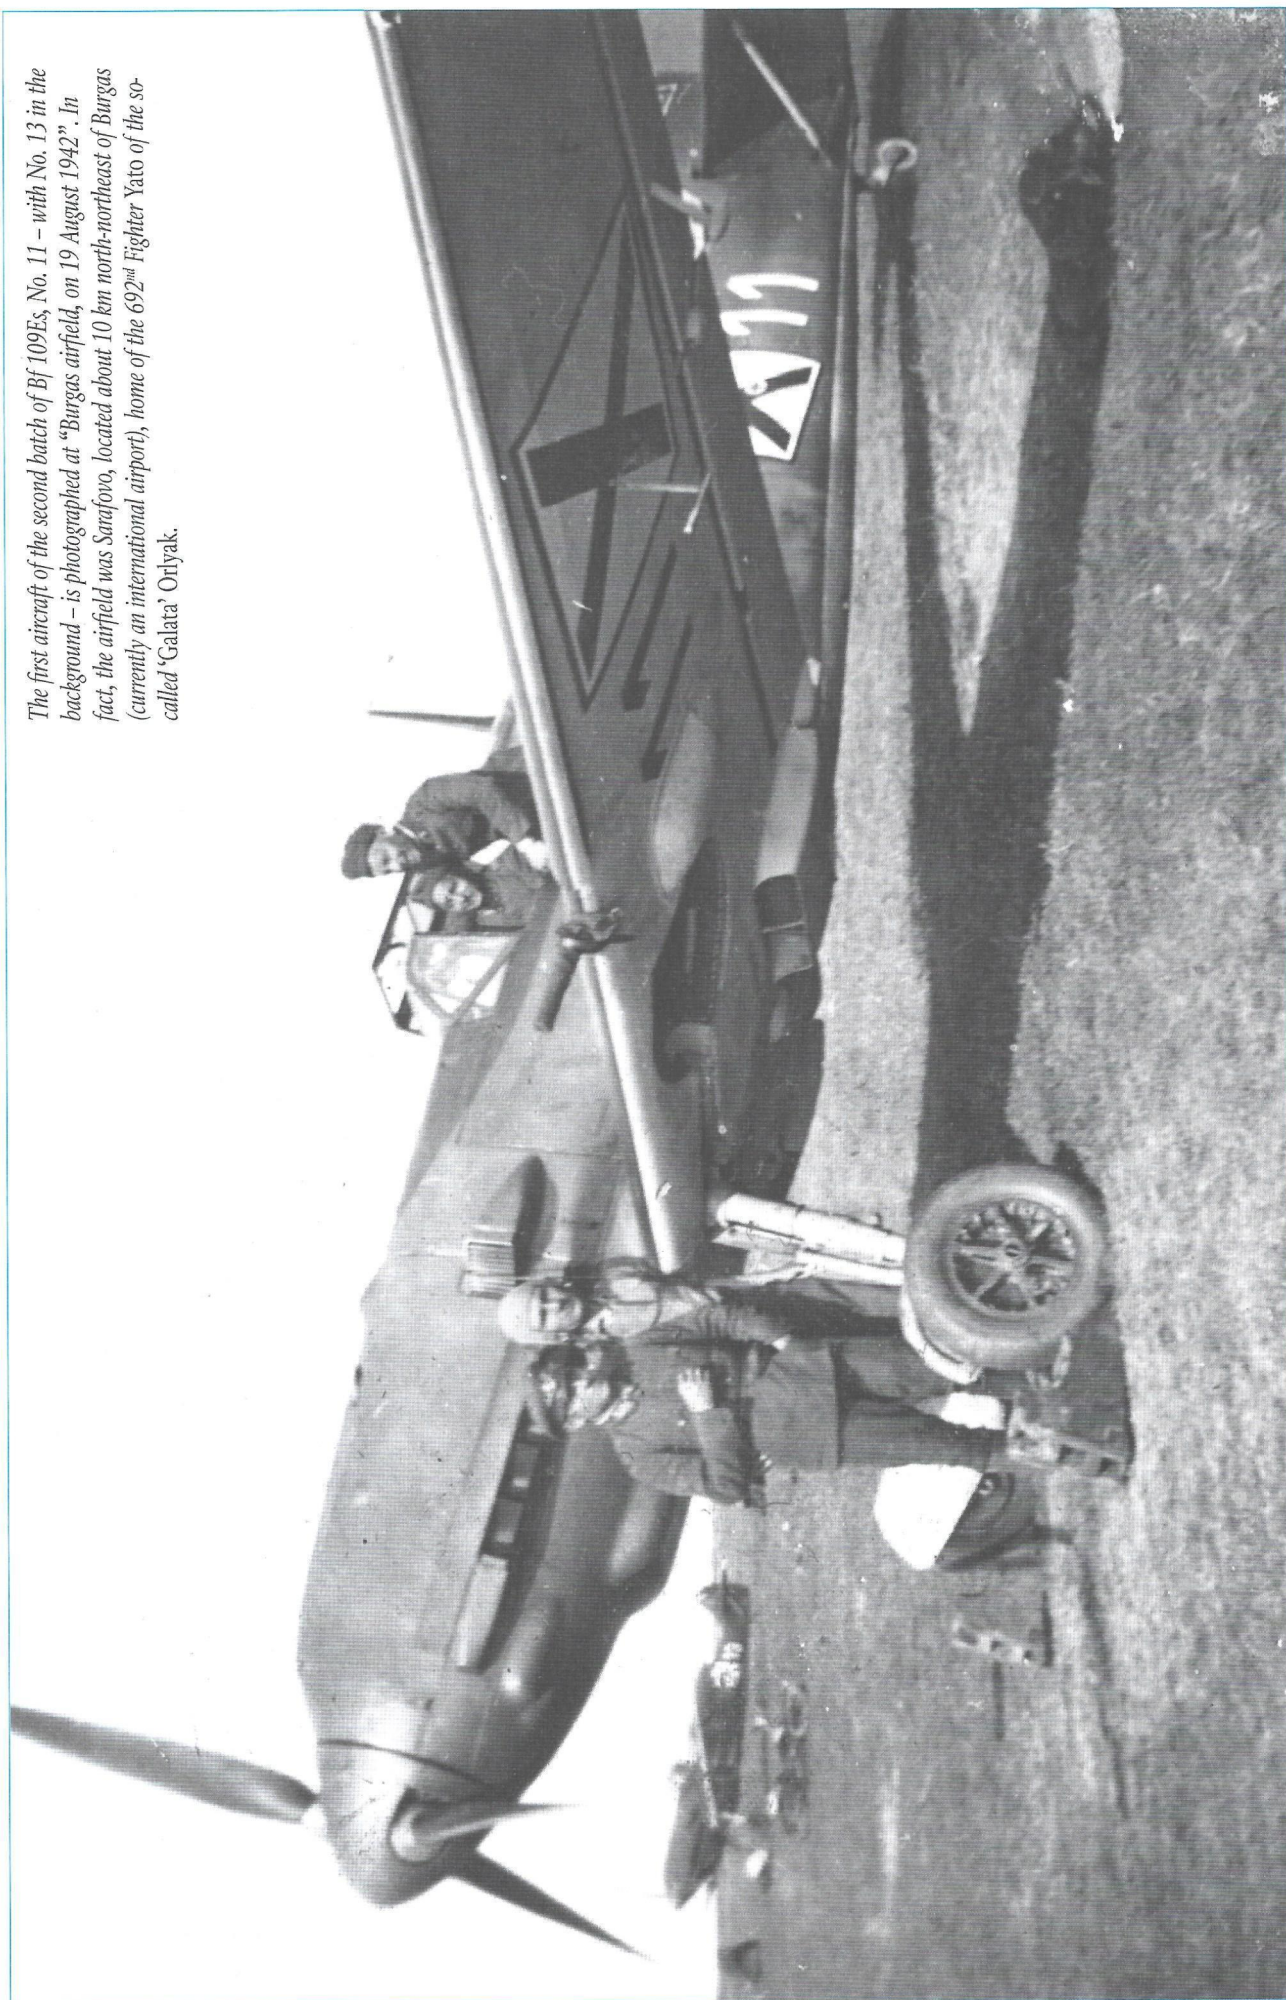
The first aircraft of the second batch of Bf 109Es, No. 11 – with No. 13 in the background – is photographed at “Burgas airfield, on 19 August 1942”. In fact, the airfield was Sarafovo, located about 10 km north-northeast of Burgas (currently an international airport), home of the 692nd Fighter Yato of the so-called ‘Galata’ Orlyak.
